## AN ELECTRICAL METHOD FOR EVALUATING BRIDGE DECK COATINGS

**RESEARCH REPORT**

**NO. M & R 635116-5**

Prepared in Cooperation with the U.S. Department of Transportation, Federal Highway Administration June, 1971

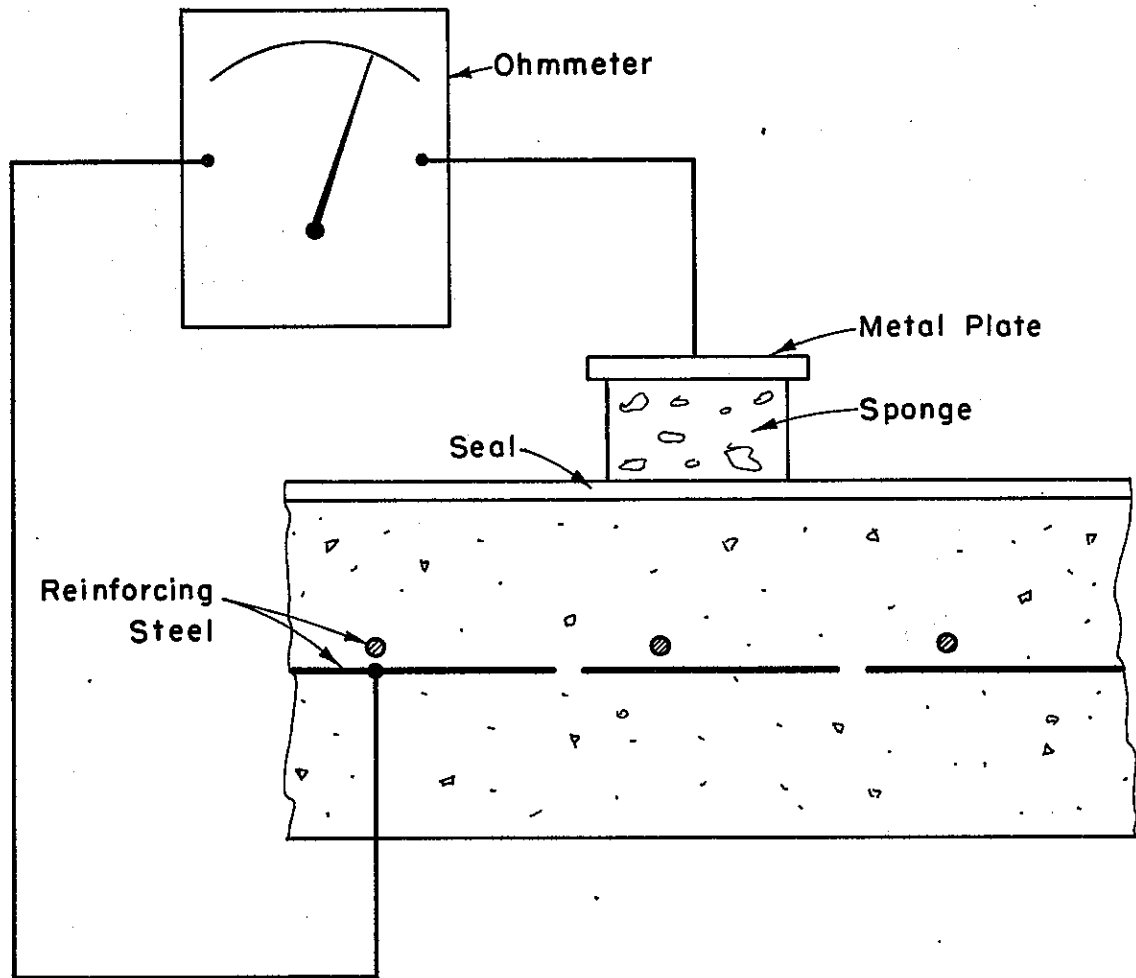
Figure 1

## METHOD FOR MEASURING RESISTANCE

The basic concept for the instrumentation is to connect one lead of the ohmmeter to a plate or contact which could be placed on the surface of the bridge deck and thus measure gross electrical resistance. This arrangement would permit the measurement of the electrical resistance from the reinforcing steel through the concrete, through the membrane and/or surface coatings, and then to the contact placed on top of the deck surface. In order to facilitate the measurement of the electrical resistance on the surface of the bridge, a moist sponge is used as a conducting medium that will electrically complete the current. See Figure 1. In constructing the contact, a piece of copper plate 7"x9"x1/8" thick was used and an electrical connection was made to the plate. A nonmetallic handle was attached to the plate for convenience in moving and placing the plate at various points on the bridge surface. Two sponges totaling about 63 square inches of area on the bottom of the plate facilitate contact with the surface. These sponges are attached by means of wooden dowels that are inserted into the sponges and secured to the plate. Because many bridge deck surfaces contain an asphaltic concrete wearing surface, water containing a wetting agent was utilized to increase the rapidity of the penetration through the asphaltic concrete. The wetting agent used is a nontoxic, nonvolatile, practically odorless ester of a sulphonated dicarboxylic acid. The wetting agent is mixed with water at the ratio of about 95 mls of wetting agent to 5 gallons of water and has a specific resistance of 2350 ohm cm.

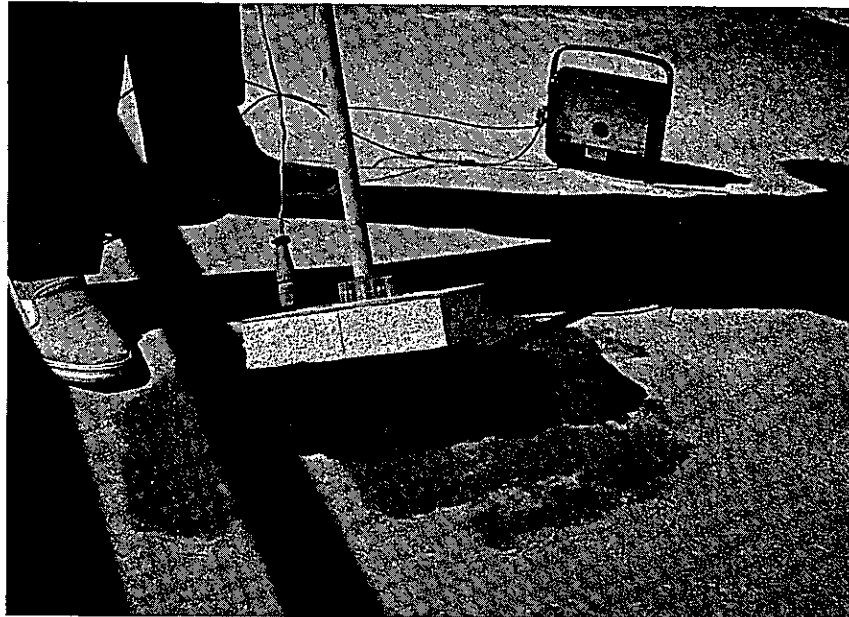
Volt-ohm-meter and apparatus to measure  
bridge deck coating.

The ohmmeter used was an ordinary general purpose voltmeter having an input impedance of 100,000 ohms per volt in the DC voltage ranges, and had a maximum readable resistance value of 200 million ohms. Figure 2 is a photo of the metal plate contact assembly which is touched to the surface of the concrete to measure the gross electrical resistance. Figure 3 shows the general setup and operations for measuring the electrical resistance of the coating.

measure the electrical resistance of the coating, a metal plate was first placed on the bench, on top of that a sponge wetted with water containing a wetting agent, then the block was placed above but in contact with the sponge. The metal plate/sponge assembly as shown on Figure 2 was placed on the sealed concrete block surface. In constructing these membranes in the laboratory, we attempted to create conditions similar to those which would be encountered in the field, as far as possible. The sealants were placed on the concrete and if required, hot asphalt concrete was compacted in the laboratory by means of a roller. In general, in the laboratory, the asphalt concrete was compacted to a density of approximately 90% or better.

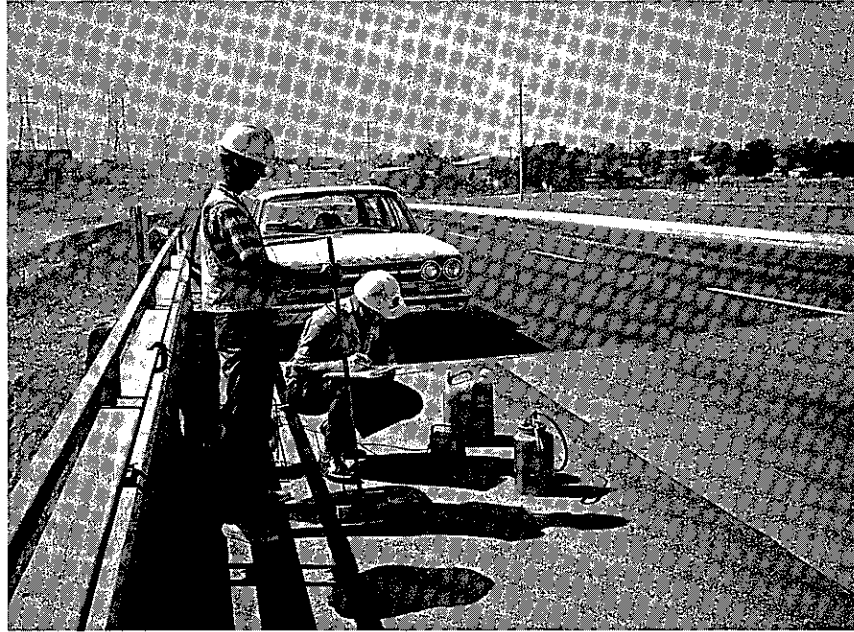
**Figure 3**

**Measuring electrical resistance of Bridge  
Deck Coating.**

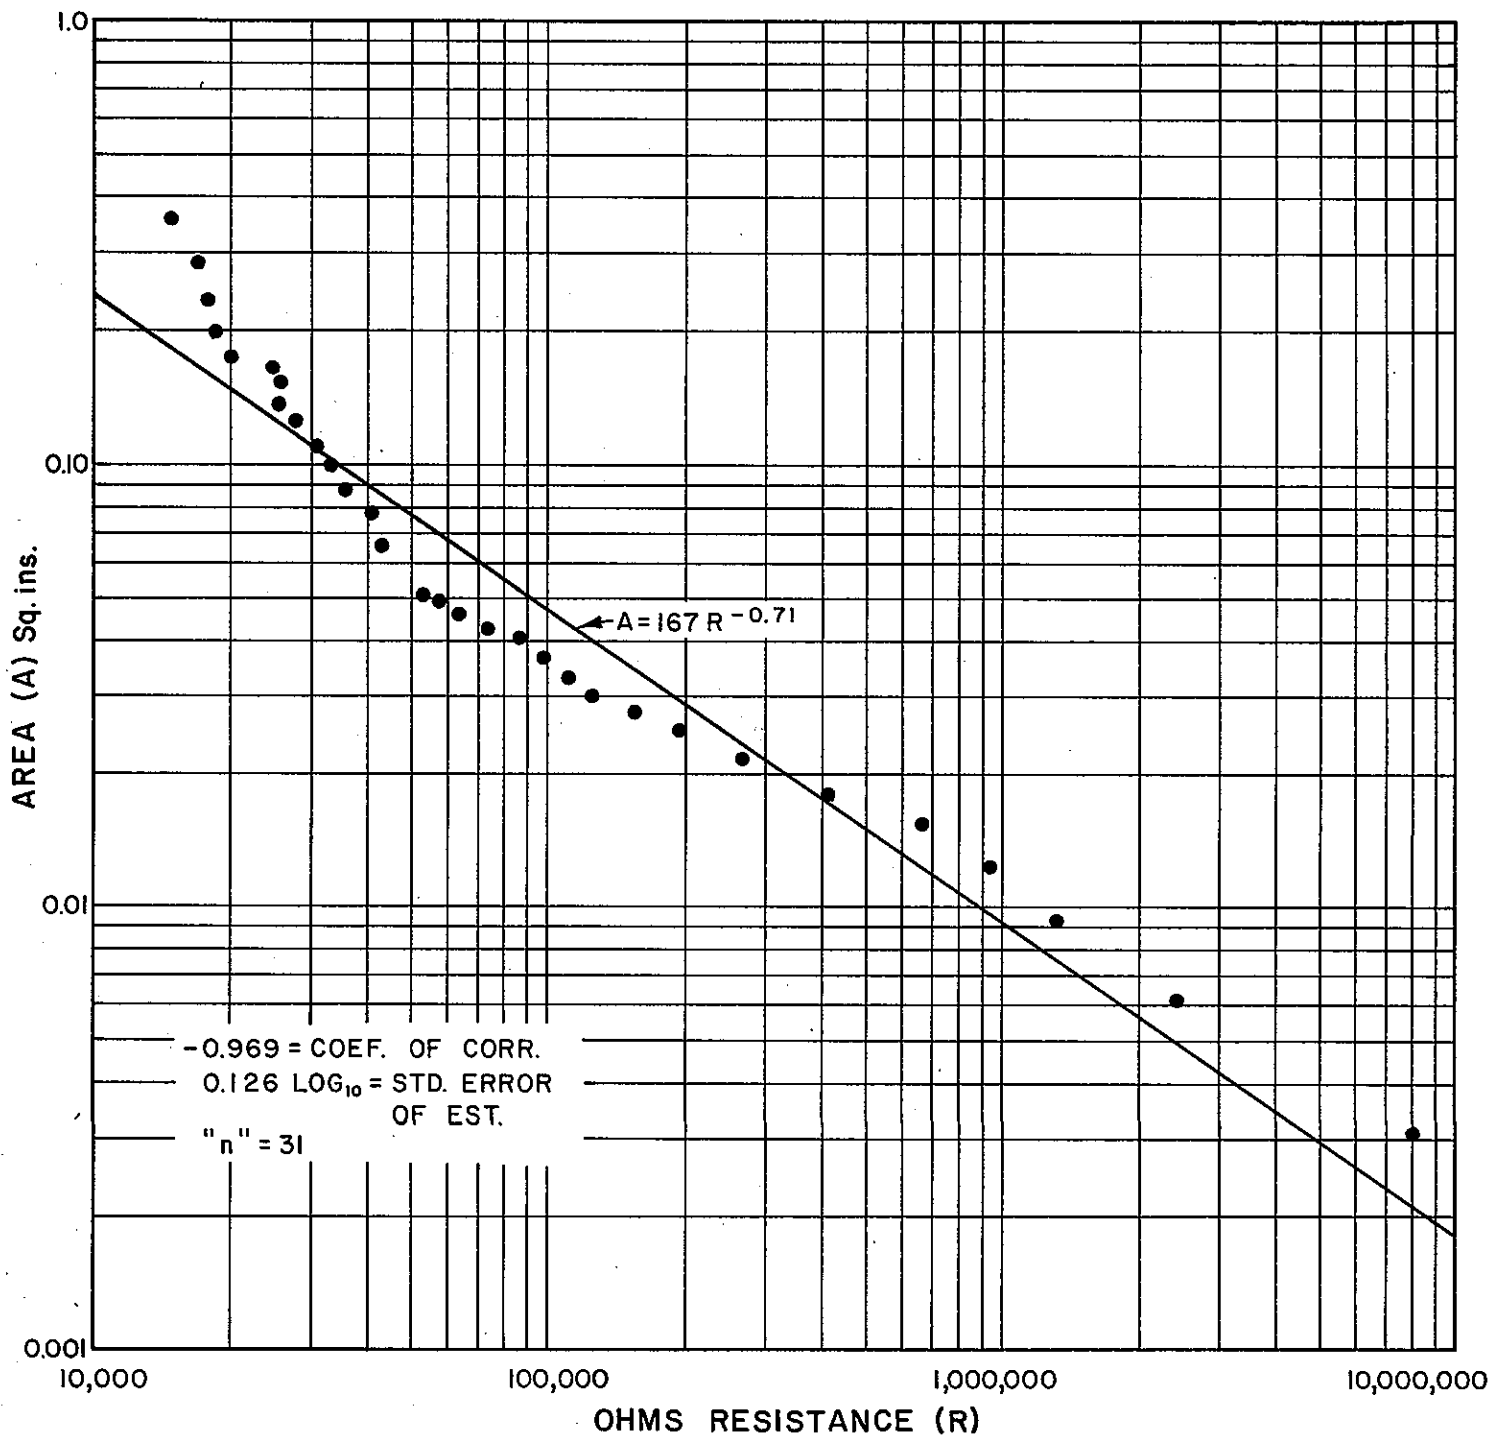
Figure 4

# AREA OF PERFORATIONS VERSUS OHMS RESISTANCE - EPOXY

For the second bridge, the same procedure of drilling holes and measuring resistance of the coating was repeated. The resulting equation and correlation is shown on Figure 4. As indicated by Figure 4, when the area of the hole is reduced by about one-half, the electrical resistance approximately triples. A further graphic representation of the influence of the perforations made in the coating to the gross electrical resistance is shown on Figure 5. In this figure, it will be noted that what might be considered a large area of holes or openings in the coating (approximately one-tenth square inch), the measured electrical resistance would be about 30,000 ohms. What might be considered as a small area of perforation (0.02 square inch), the measured resistance would be approximately 250,000 ohms. Fortunately, in the area of holes we are interested in, the sensitivity to electrical resistance is greatest.

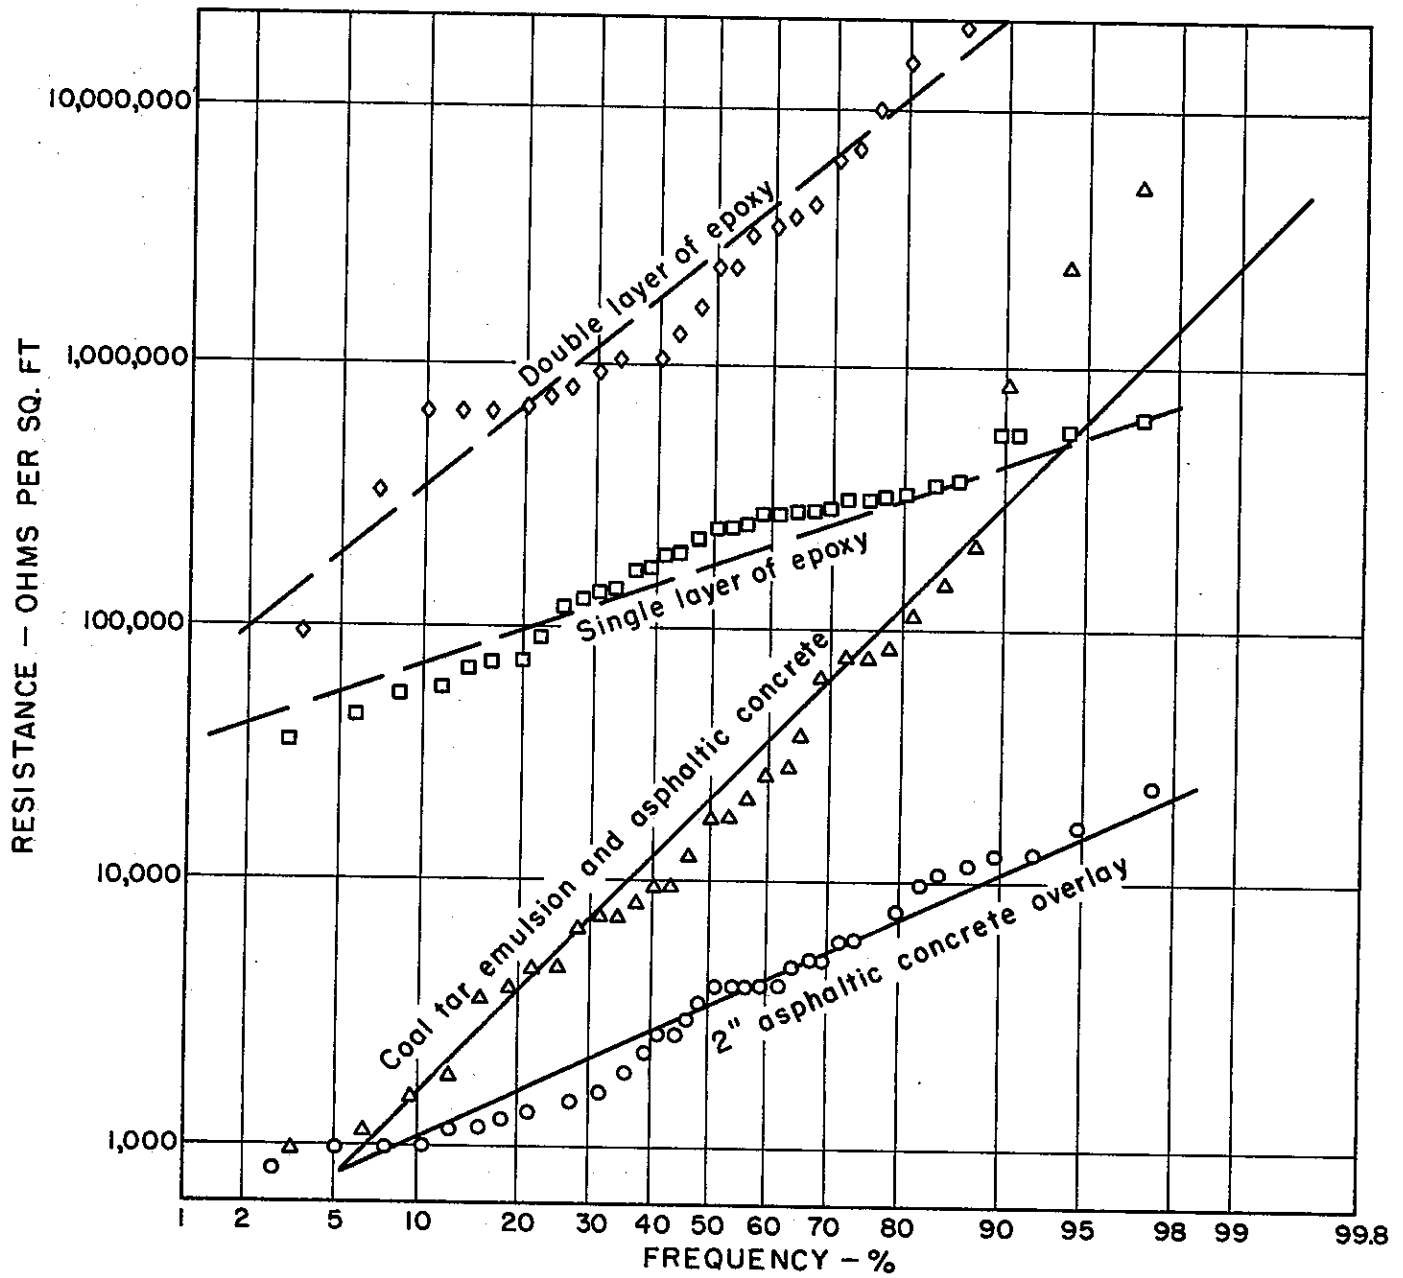
Figure 6

# GROSS RESISTANCE OF DECK COATINGS

Two techniques for measuring coating resistance have been utilized. One is by obtaining at least twenty resistance measurements at random across the deck. The values are then plotted on probability paper as shown on Figure 6. The other method is to systematically measure the resistance values on approximately 5-foot interval grid across the bridge deck. Then by making a contour map of equal resistance values, areas of low resistance contours could indicate the location of significant larger perforations of the coating.

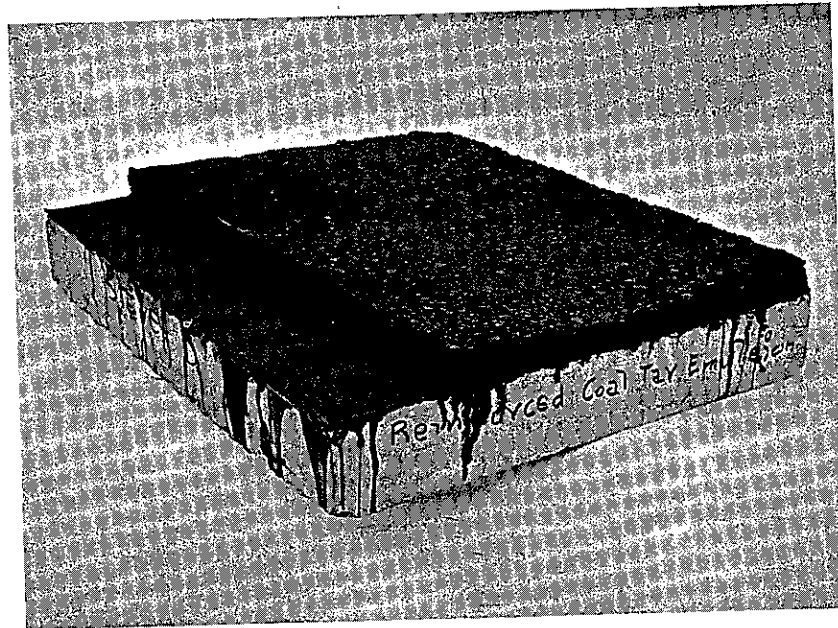
Figure 7

Laboratory test of bridge deck coating on  
3" x 18" x 24" concrete block.

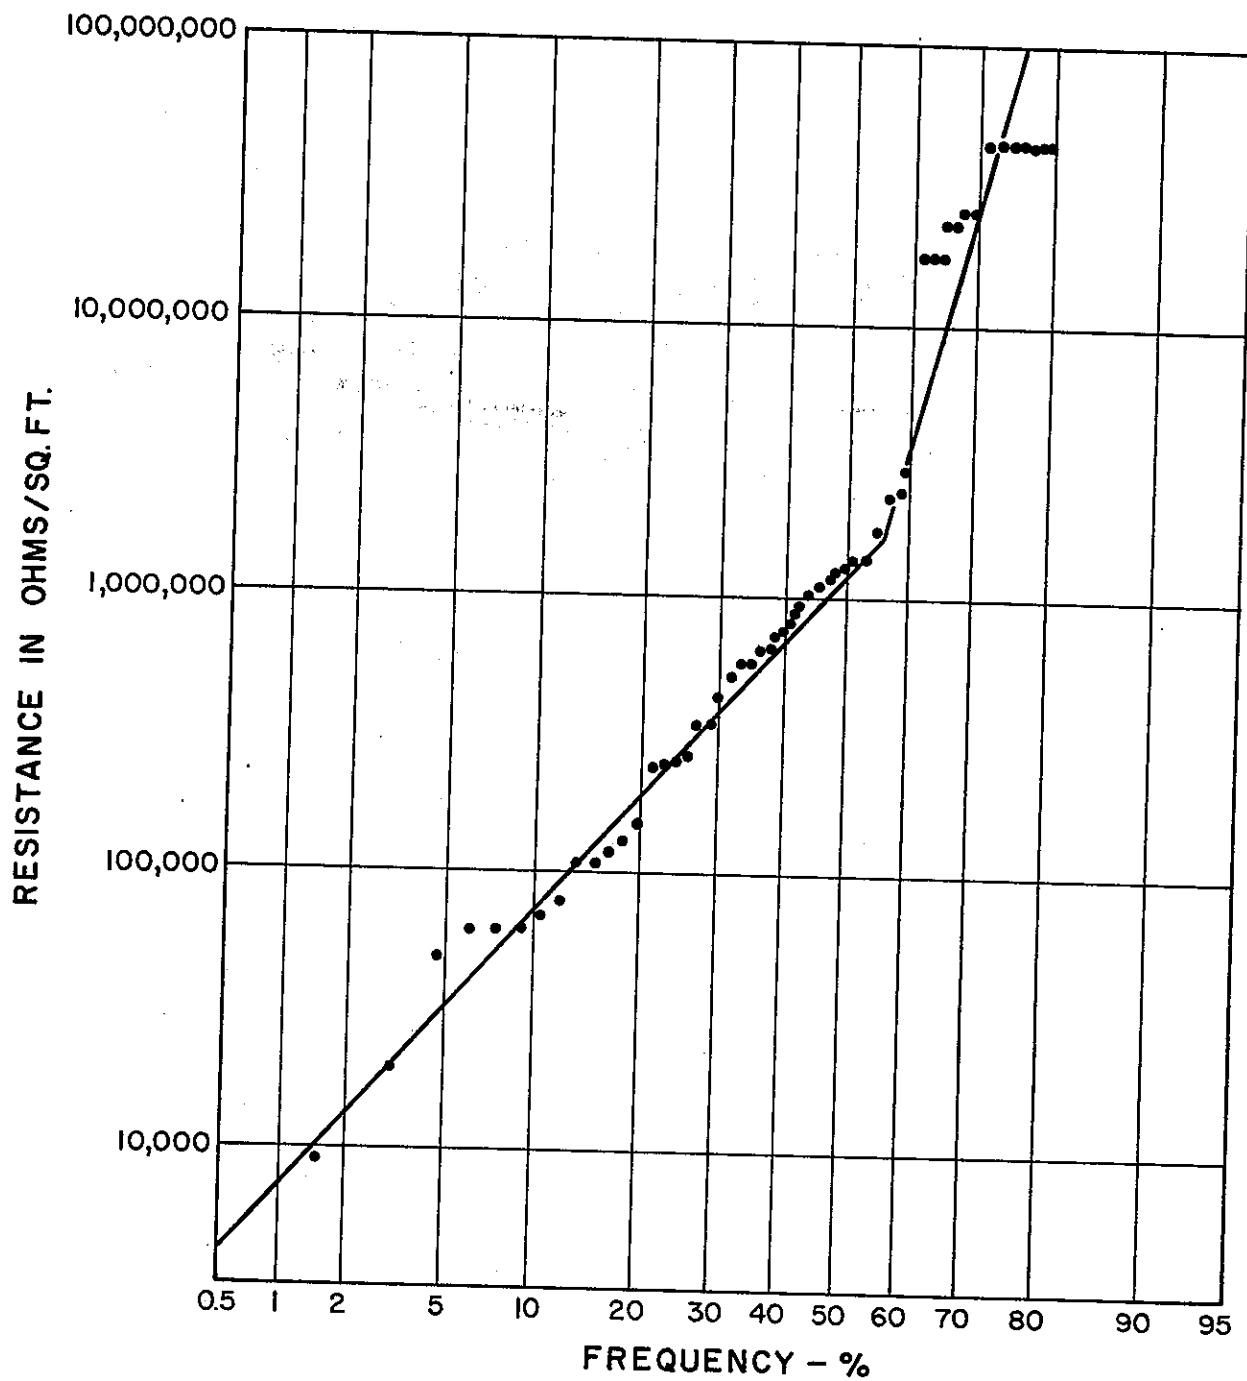
Figure 8

RESISTANCE OF REINFORCED  
EXTENDED COAL TAR MEMBRANE  
AND 1" OF ASPHALT CONCRETE

SUSAN RIVER BRIDGE 02-LAS-395

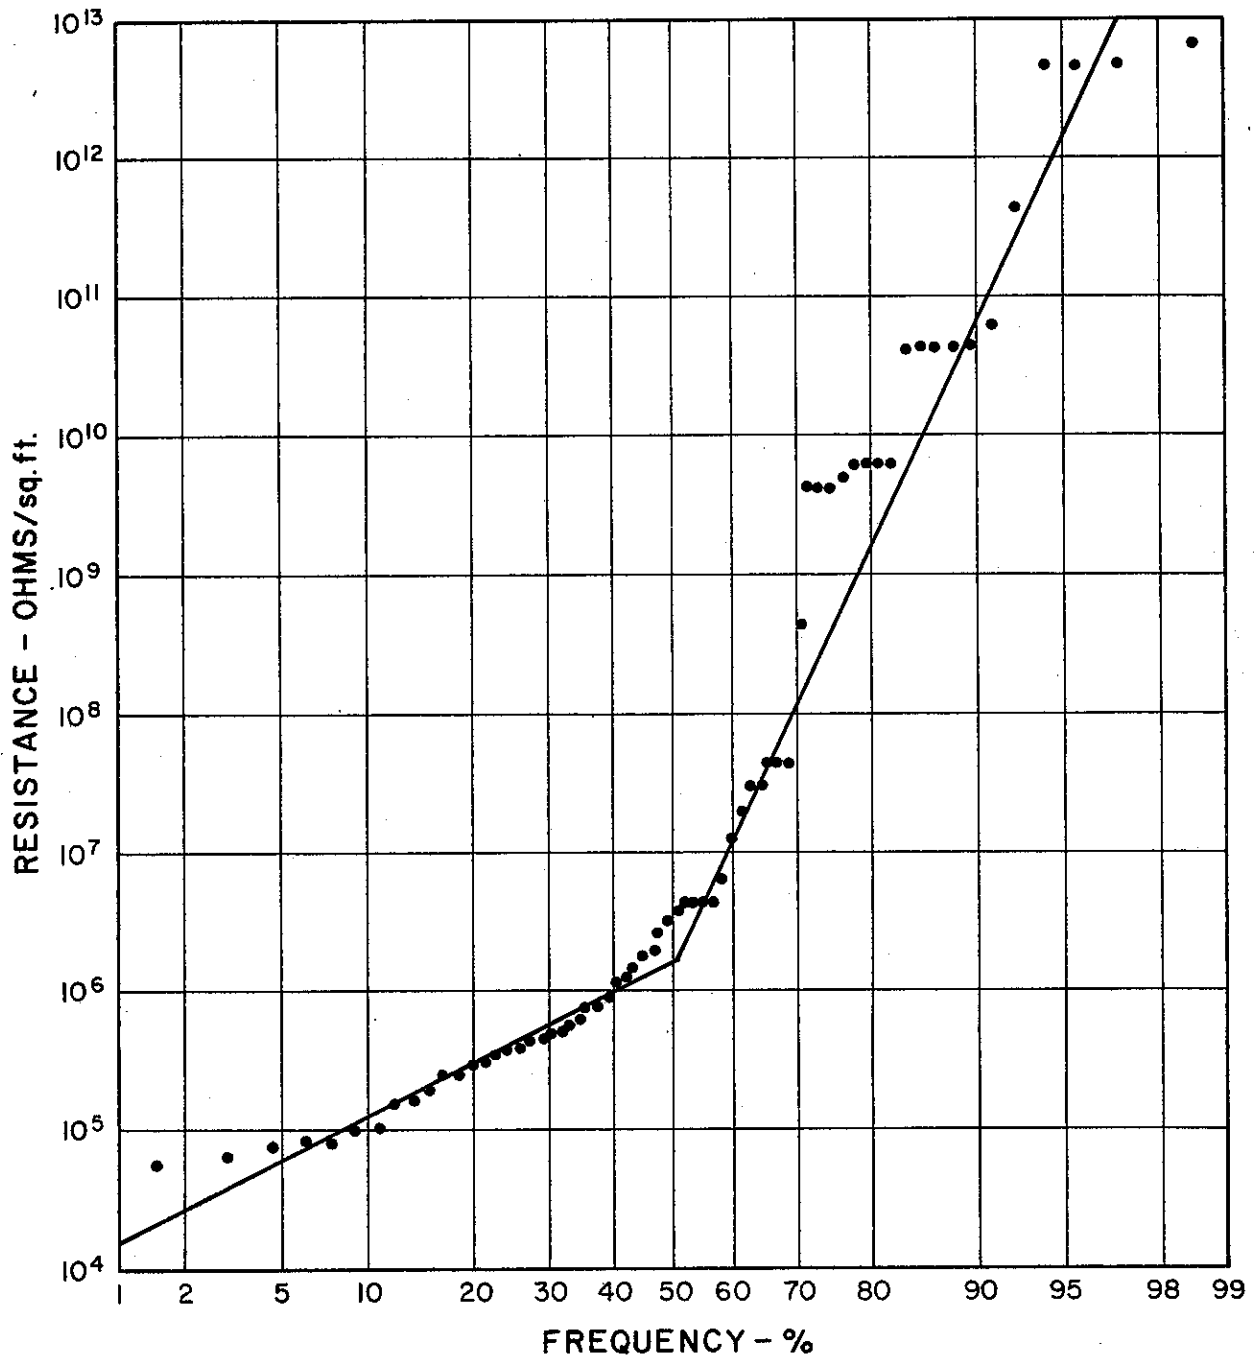
Figure 9

# RESISTANCE OF REINFORCED EXTENDED COAL TAR AND 3 INCHES OF ASPHALT CONCRETE

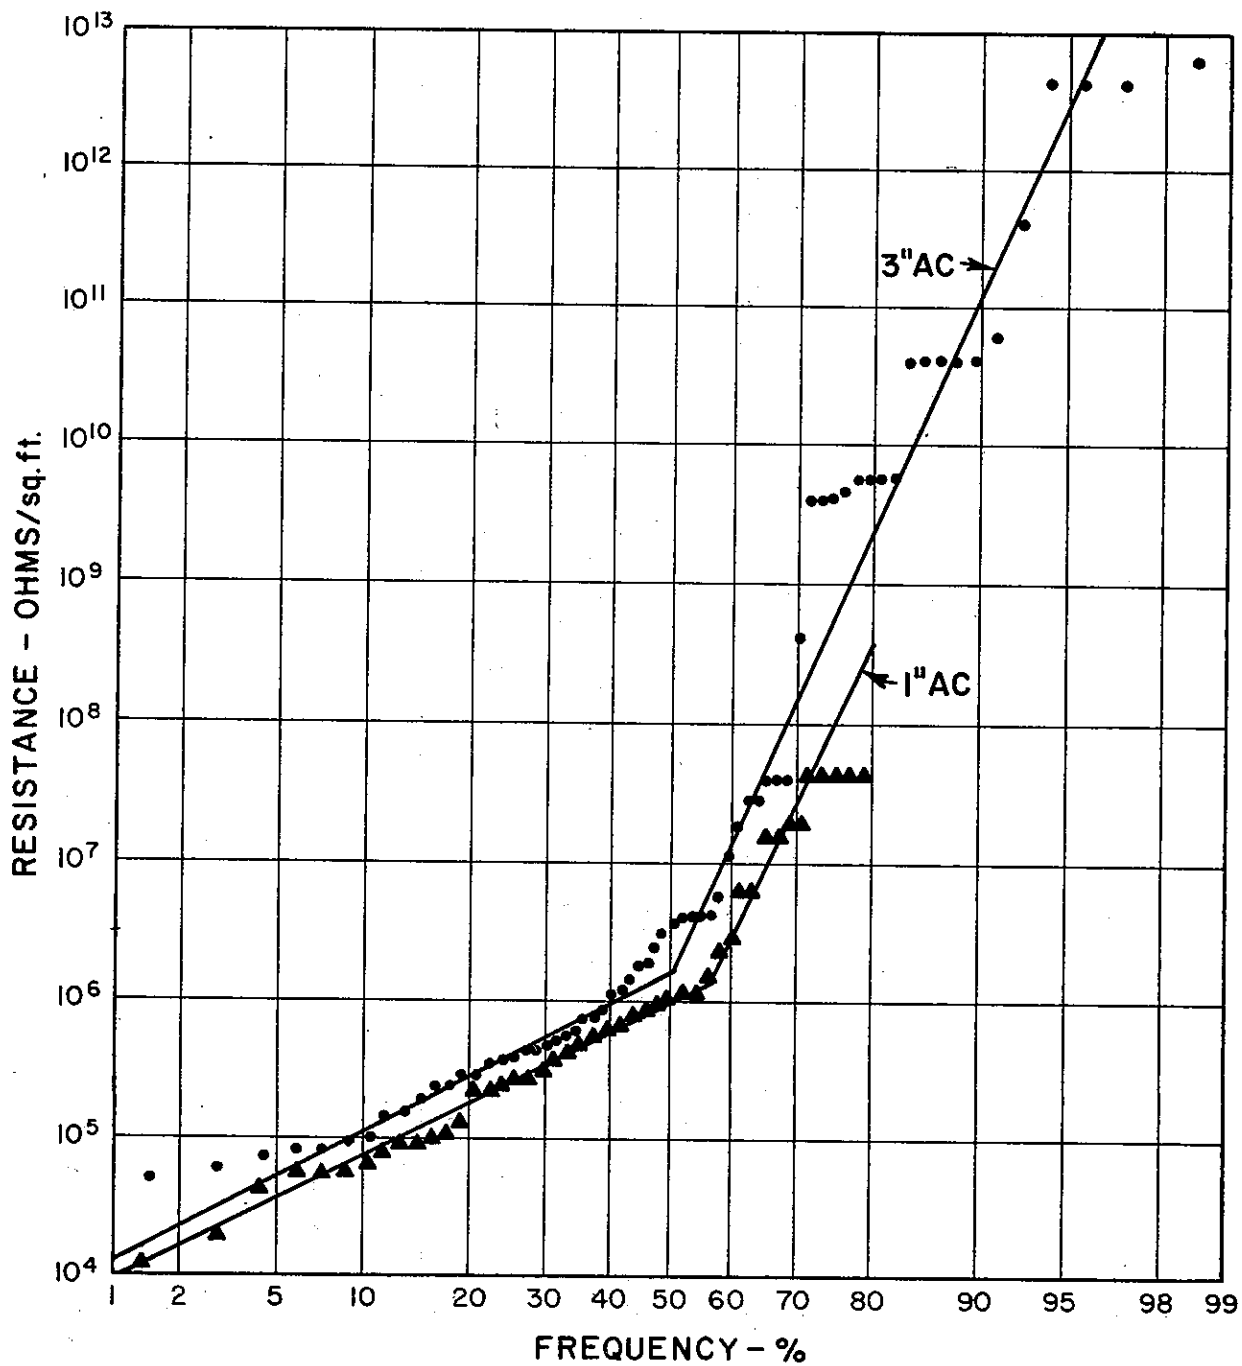
Figure 10

# RESISTANCE OF REINFORCED EXTENDED COAL TAR WITH 1 AND 3 INCHES OF ASPHALT CONCRETE

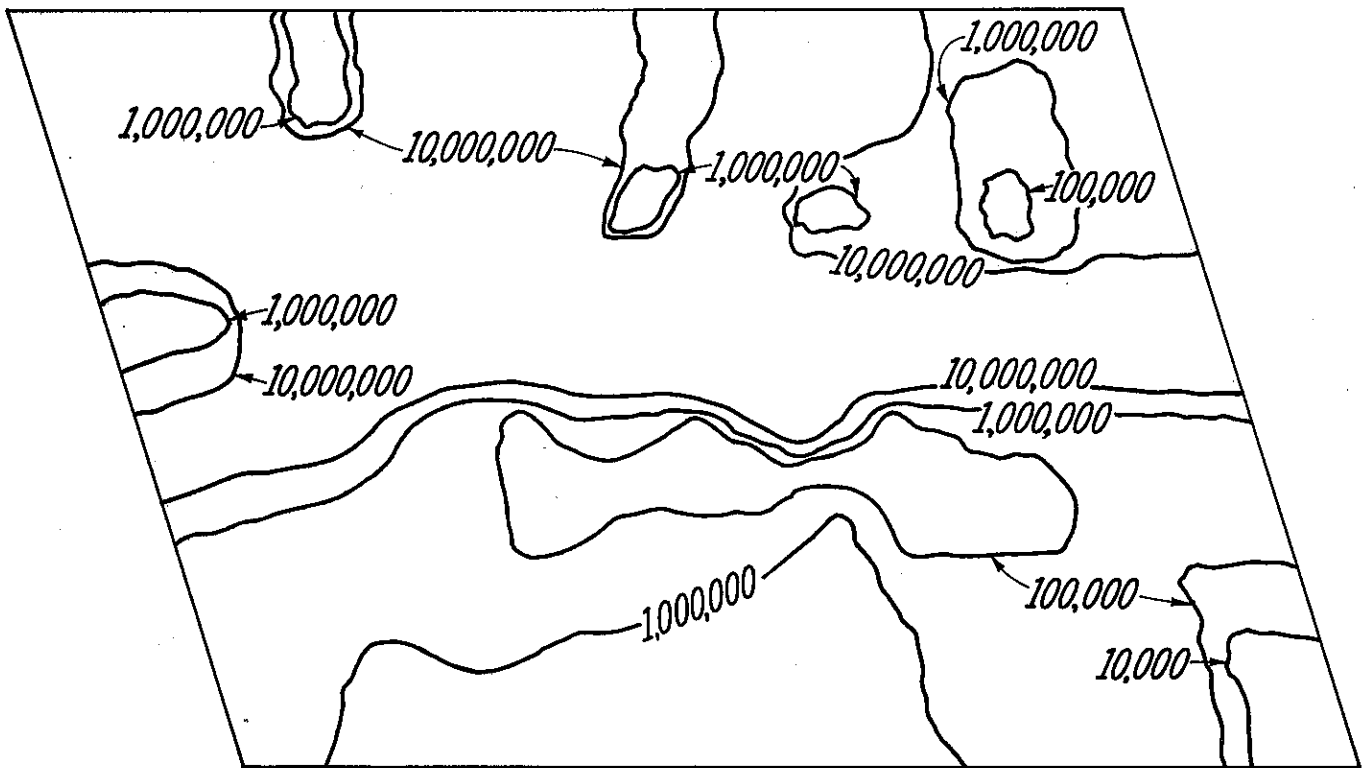
**Figure 11**

**EQUI-RESISTANCE CONTOURS  
OF BRIDGE DECK MEMBRANE-OHMS/SQ. FT.**

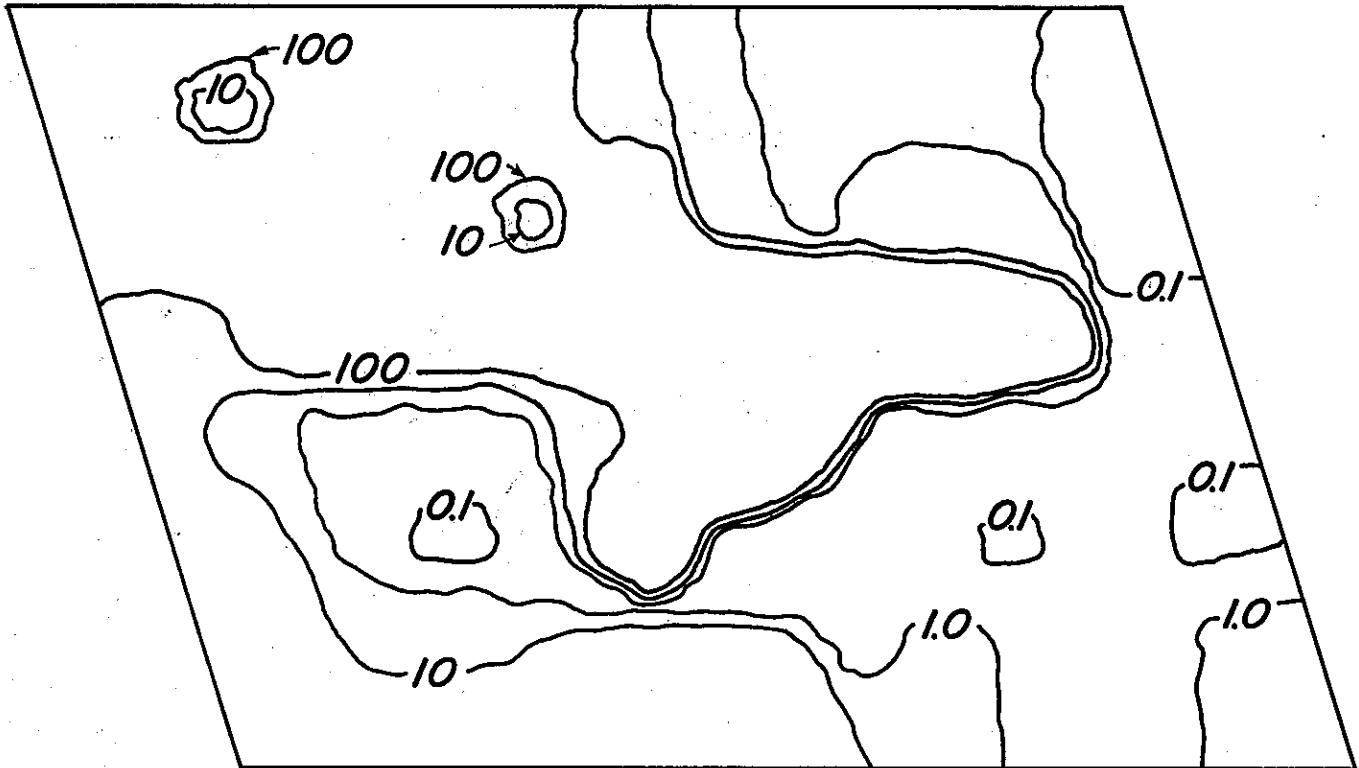
**Figure 12**

**EQUI-RESISTANCE CONTOURS  
OF BRIDGE DECK MEMBRANE MEG-OHMS/SQ.FT.**
